Chapter 7

Description of Impacted Native American Resources in the Engineering Sciences and Applications Division

BACKGROUND FOR THE ESA ASSESSMENT

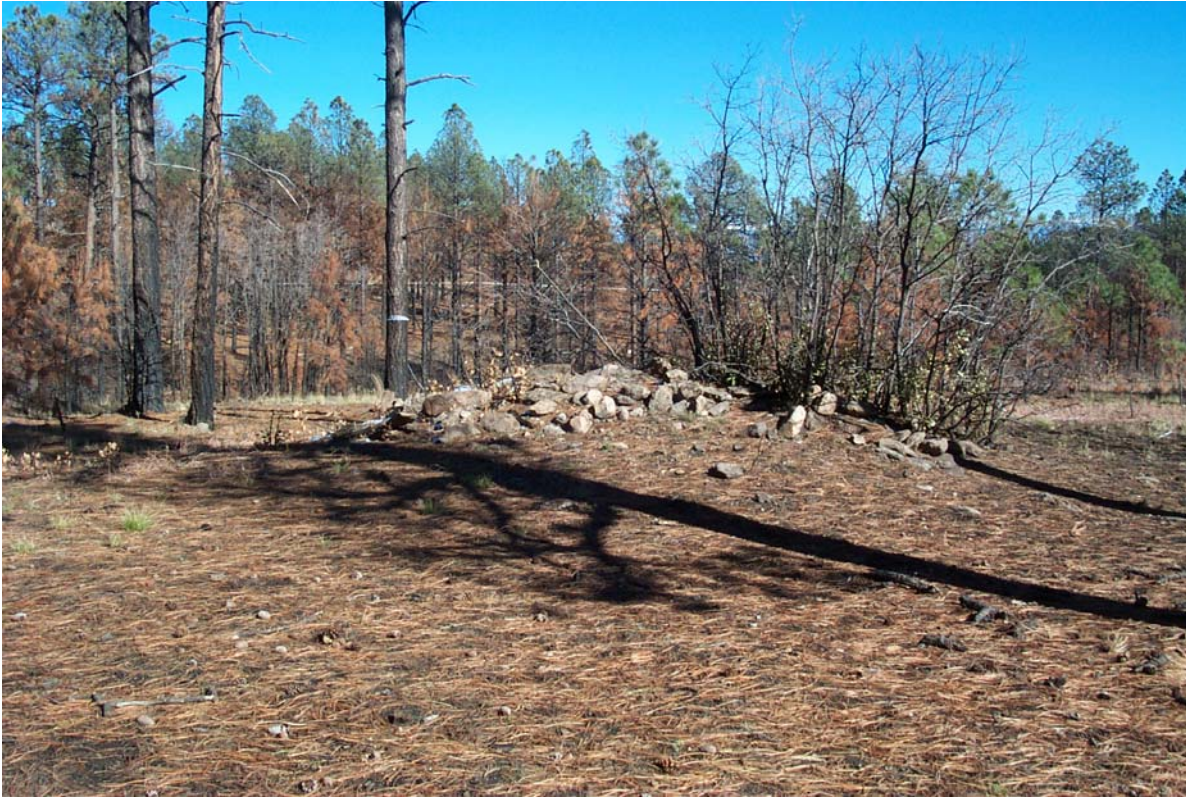
LA 204. The site consists of a two-room structure (6 m by 2.5 m, 1 m high) of well-shaped tuff blocks (Figure 7.2). The site is located on a very gentle east-facing slope just north of Water Canyon. The vegetation is dominated by ponderosa pines. This site is Ancestral Puebloan. The area around this site was moderately burned. There are four snags in the area and two stump holes, but these do not pose a threat to the site. Twenty percent of the masonry is soot damaged. There is a low-level threat from erosion at the site because duff in the area was burned off during the fire. Rehabilitation efforts have taken place near the site; there has been tree cutting in the area and excelsior matting has been placed south of the site. These activities do not seem to have negatively impacted the site.

Figure 7.2. General view of LA 204, looking east-northeast.

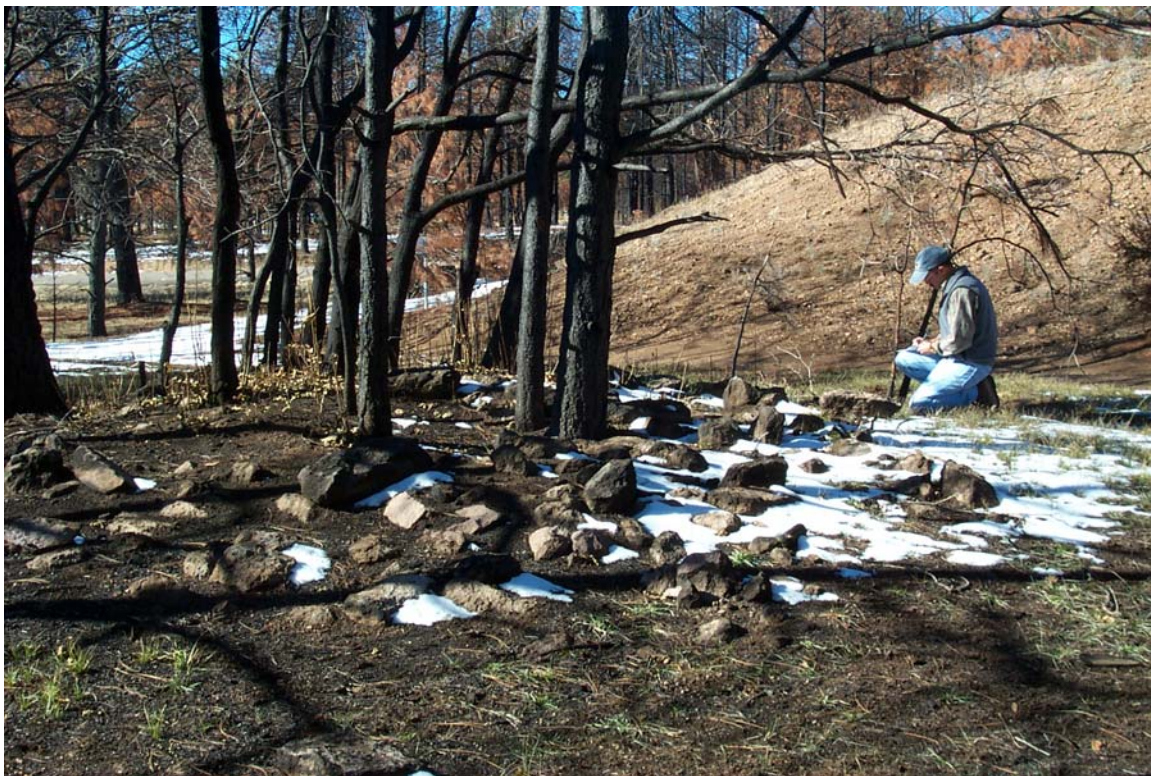
LA 15858. This site consists of a one- to two-room structure (4 m by 4 m, 0.3 m high) of roughly shaped tuff blocks (Figure 7.3). Despite being located adjacent to a building in the developed western part of TA-16, there was a fair sized stand of ponderosa pines and some smaller tree species growing on and around the site. The site is composed of lichen-covered, roughly shaped tuff blocks and rubble. No artifacts were

Figure 7.3. View looking south of LA 15858 with B. Vierra.

observed in association with this site. This site is Ancestral Puebloan. The area around the site was severely burned. Nearly all the trees in the immediate area were burned and several trees near the site could damage it if they fall. Sixty percent of the masonry is soot damaged and 10% is heat spalled. Many of the burned trees in the area have been cut down as part of the rehabilitation effort, but the trees immediately surrounding the site still stand.

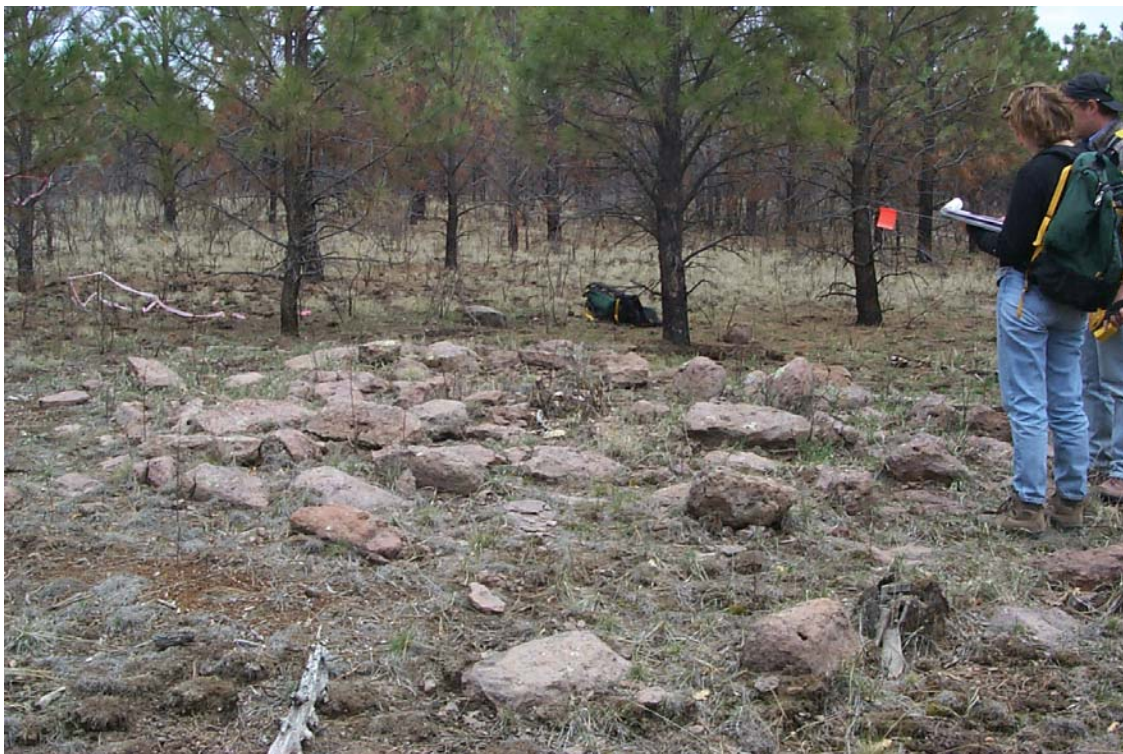
LA 21370. This site consists of a small rubble mound of shaped tuff blocks (Figure 7.4). The mound may be recent or the blocks were cannibalized from another site in the vicinity. There are no visible remains of an old horseshoe were located. Due to the lack of artifacts, the site affiliation is undetermined. This site had been previously burned in 1977 during the La Mesa Fire. The site is located in a cleared meadow approximately 150 m north of State Route 4 and 40 m south of the Water Canyon cliff edge. The effects from the Cerro Grande Fire include stump and root holes adjacent to masonry, stump and root holes in the site area, and additional snags or partially burned trees in the site area. There were no suppression impacts to the site. No treatment is recommended for this site.

Figure 7.4. General view looking east of LA 21370 with J. Nisengard (left) and B. Harmon.

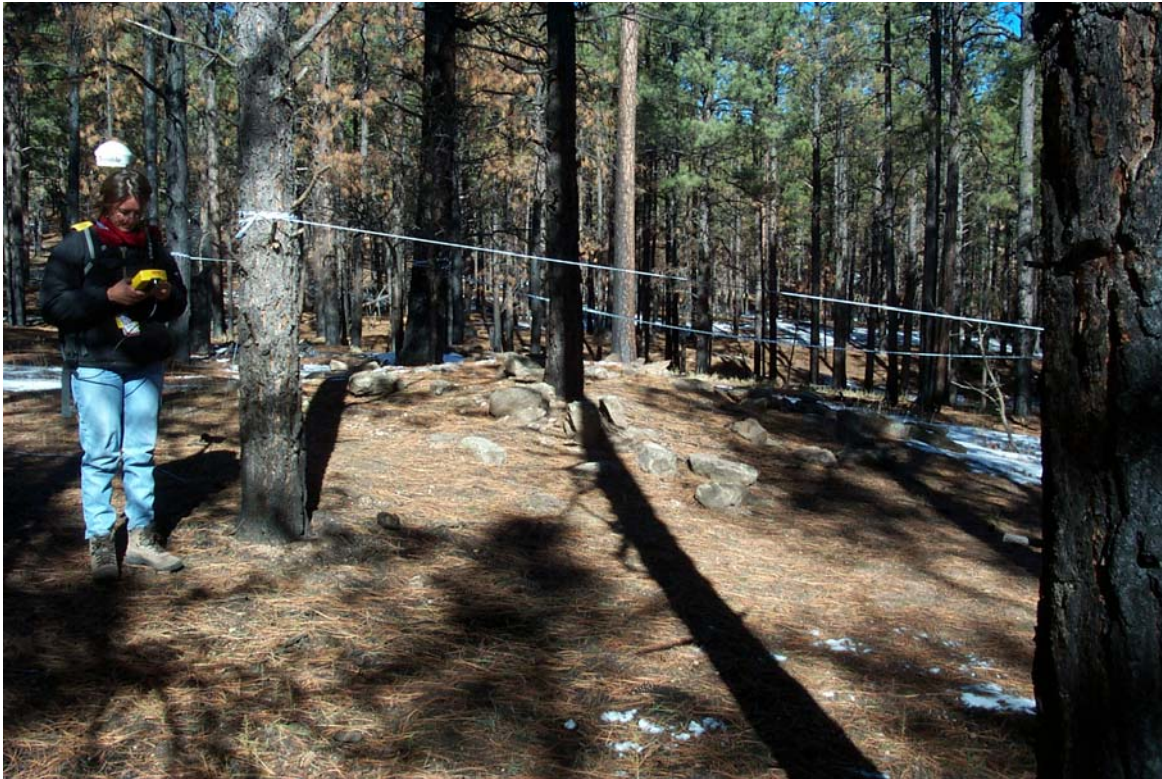
LA 86653. This site consists of a two-room structure (5 m by 3 m) of well-shaped tuff blocks (Figure 7.5). The site is located on a gentle east-facing slope incised by several small drainages in a ponderosa pine forest. The tuff blocks are well shaped and some are quite large. No coursing or alignments are visible. Approximately 25 artifacts were observed in association with this site, scattered over an area measuring 15 m north-south by 15 m east-west. This site is Coalition. The area around the site was moderately burned. There is one snag in the site area, and 20% of the masonry is soot damaged. There is also a low erosional threat due to the absence of duff that was burned off.

Figure 7.5. LA 86653, J. Nisengard at the two-room structure impacted by the fire.

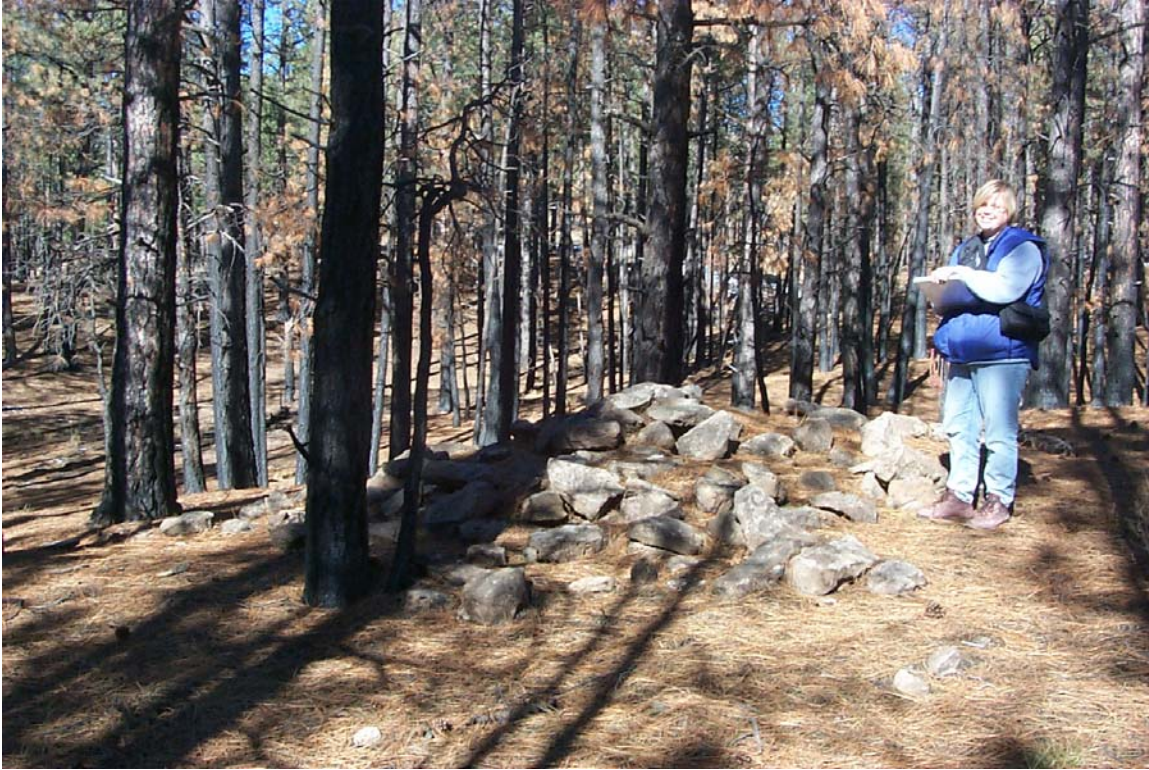
LA 86655. This site is a one-room structure (4 m by 3 m) of shaped tuff blocks (Figure 7.6). The site is located on a gentle south-facing slope incised by several small drainages in a ponderosa pine forest. This site is Ancestral Puebloan. The area around the site was severely burned. There are five stump holes and many snags in the site area, but they do not pose a threat to the site. Although there is minimal soot damage, 25% of the masonry is heat spalled. There is also a low erosional threat to the site.

Figure 7.6. General view looking north of LA 86655 with K. Schmidt.

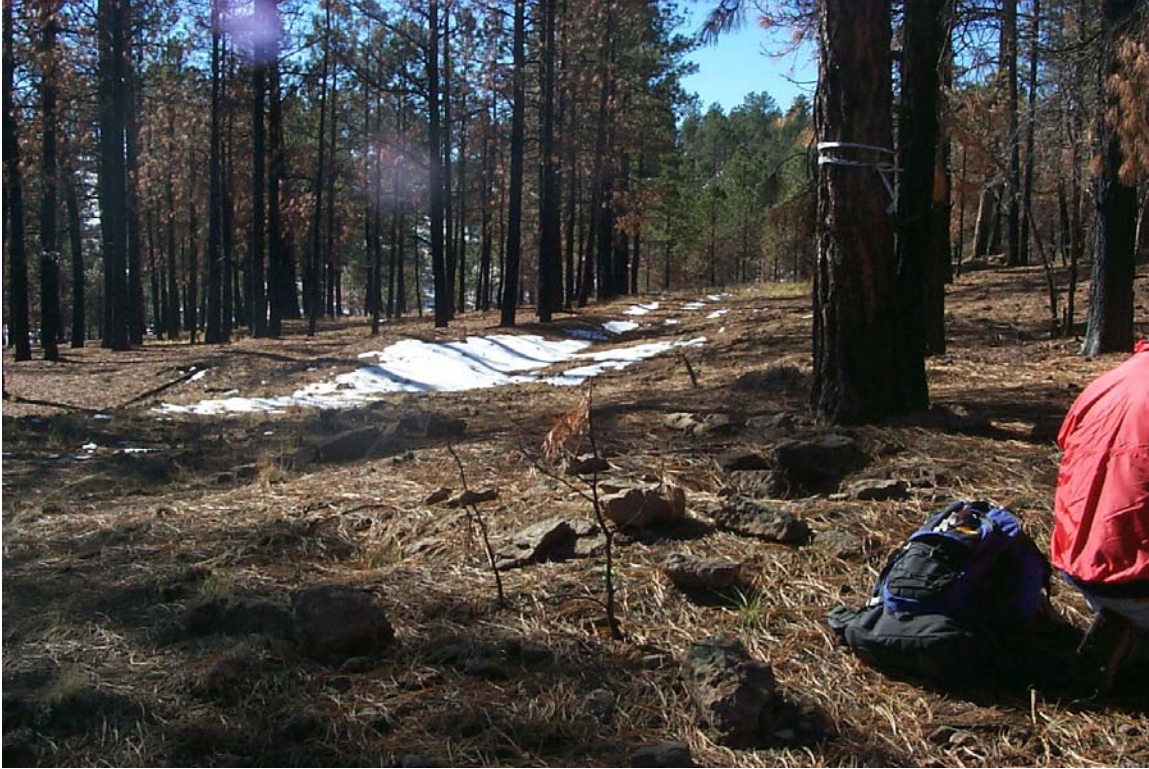
LA 86656. This site is a two- to three-room structure (3 m by 3 m) of roughly shaped tuff blocks. The site is located on a gentle southeast-facing slope incised by several small drainages in a ponderosa pine forest. Based on ceramics observed by earlier surveys, this site dates to the Coalition period. The area around the site was moderately burned. There are four snags in the area and an additional snag that could damage the site if it falls. An old bulldozer firebreak not related to the Cerro Grande Fire has disturbed the eastern edge of the site (Figure 7.7).

Figure 7.7. General view of LA 86656, looking south. Note burned tuff blocks along the edge of an old bulldozed firebreak road.

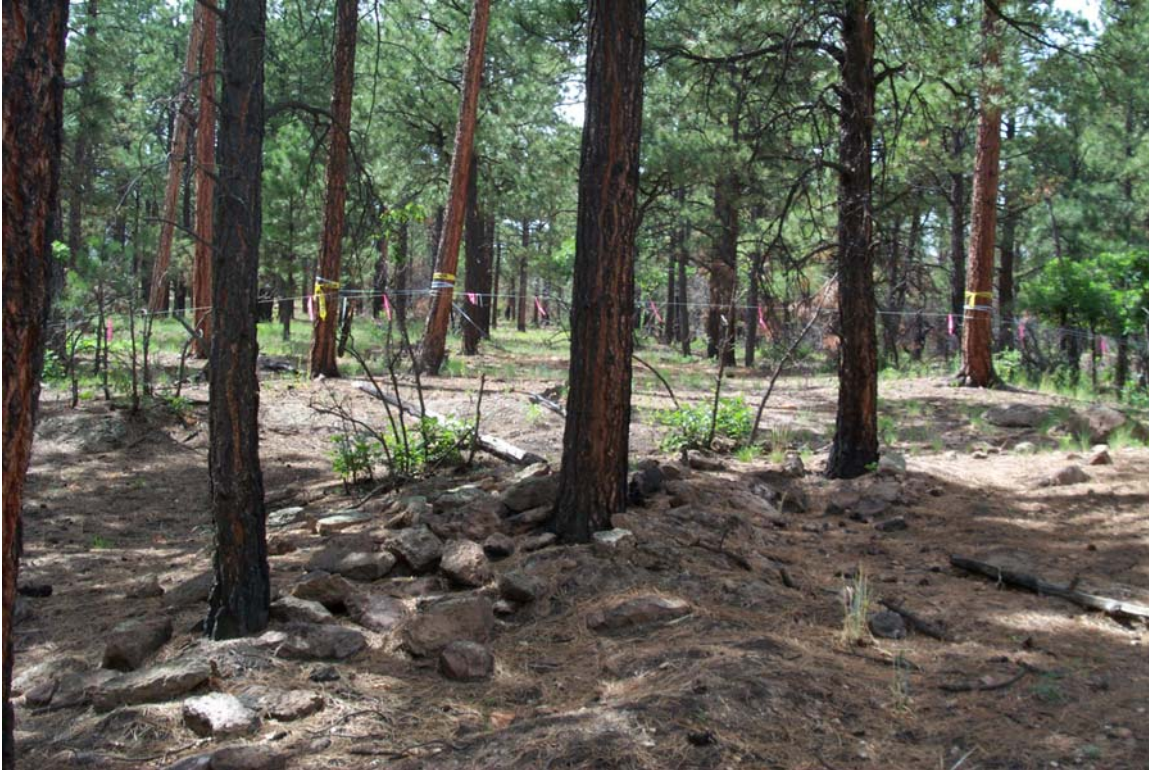
LA 136905 (K-166). This site consists of a small mound with shaped and unshaped tuff blocks (Figure 7.8). It is located in a ponderosa pine forest and is approximately 30 m by 30 m in size. No artifacts were identified at the site, so it has been classified as Ancestral Pueblo. The site burn severity is moderate, and fire effects at the site include cracking and spalling of masonry, smoke damage, and stump and root holes in the site area. Some of the burned tress in the site area were removed, and no treatment is recommended.

Figure 7.8. General view of LA 136905 after flagging, looking southeast.

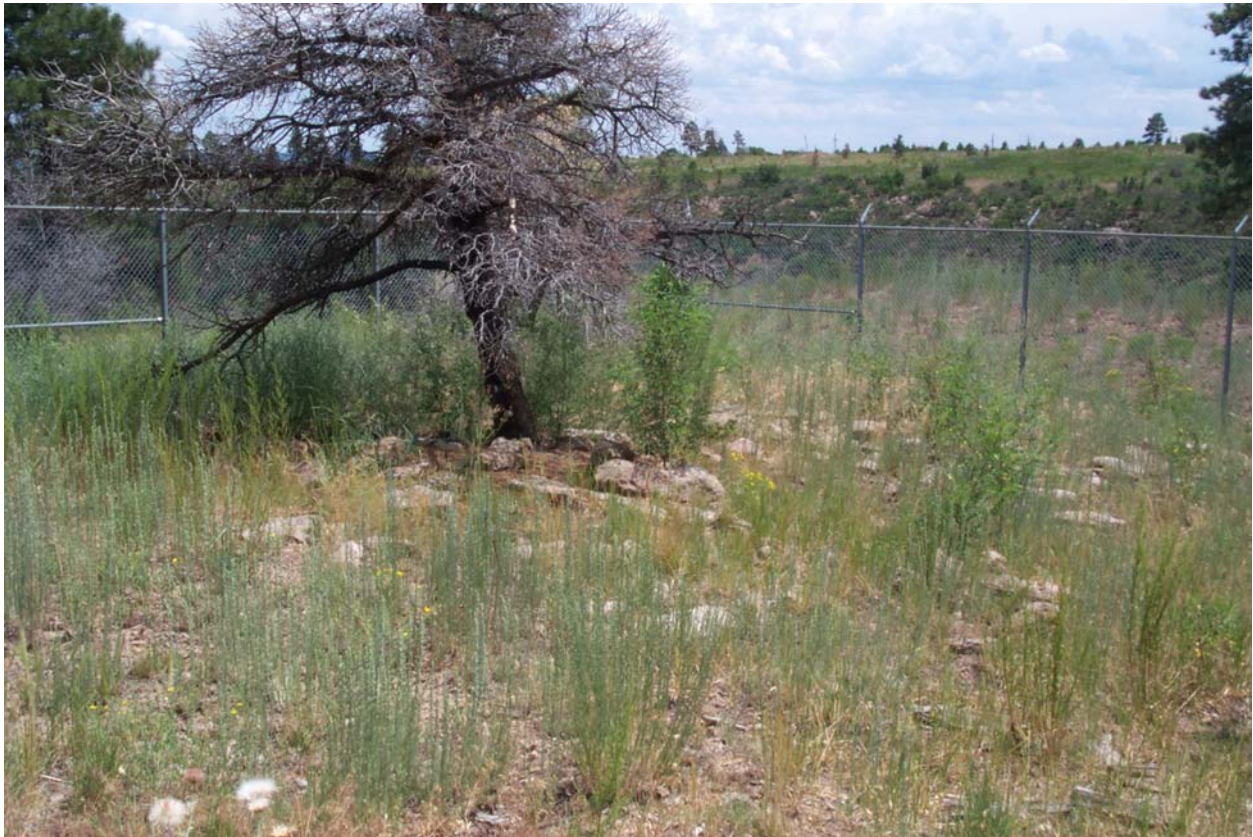
LA 4654A. This site consists of a small pueblo roomblock located near the south edge of the TA-37 mesa top that overlooks Water Canyon. The site is approximately 15 m by 13 m, and alignments are visible in the central area of the structure. The tuff blocks are well shaped and unusually large. A chain link fence deviates around the mound on the south side of the site (Figure 7.9). Some bulldozing is evident in this area. The large majority of the roomblock component of this site, despite having been damaged by the fence construction, is undisturbed. Artifacts observed include Santa Fe Black-on-white, some corrugated utility ware, basalt, chert, and chalcedony. Based on the ceramics observed, this site dates to the Coalition period. The effects of the Cerro Grande Fire are moderate and consist of cracking and spalling of masonry, smoke and soot staining, snags and partial burned trees that can damage structures, and additional snags and burned trees in the site area. There were no suppression impacts to this site during the fire. The removal of a burned and dead tree from the center of the rubble mound is recommended treatment for this site.

Figure 7.9. LA 4654A; the tree in the center of the rubble mound is recommended for removal.
